# Lake Dalecarlia Watershed Diagnostic Study Public Meeting

PRESENTER:  
Tom Estrem with Cardno

November 15, 2021

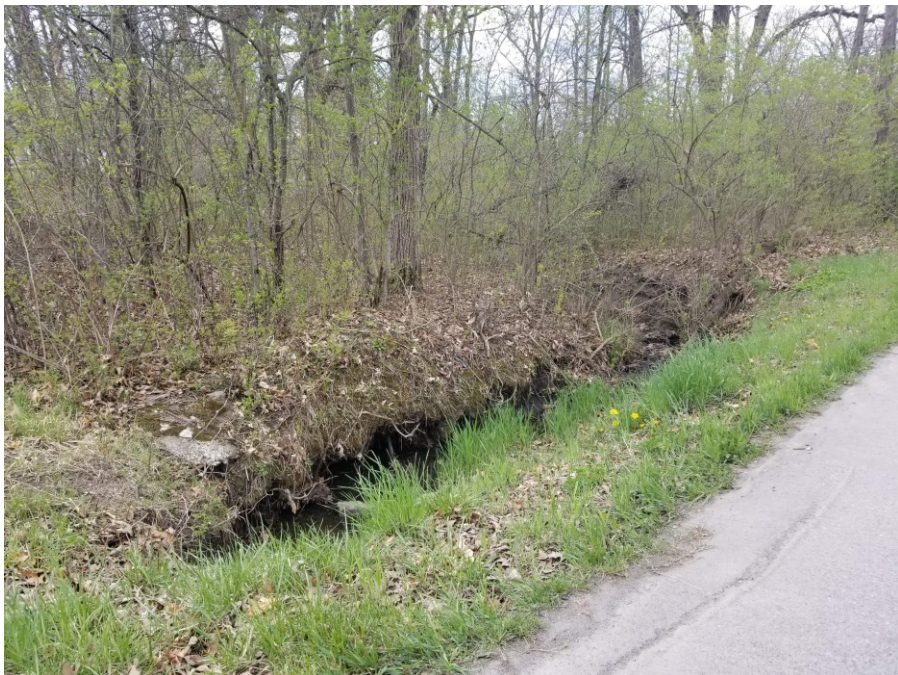
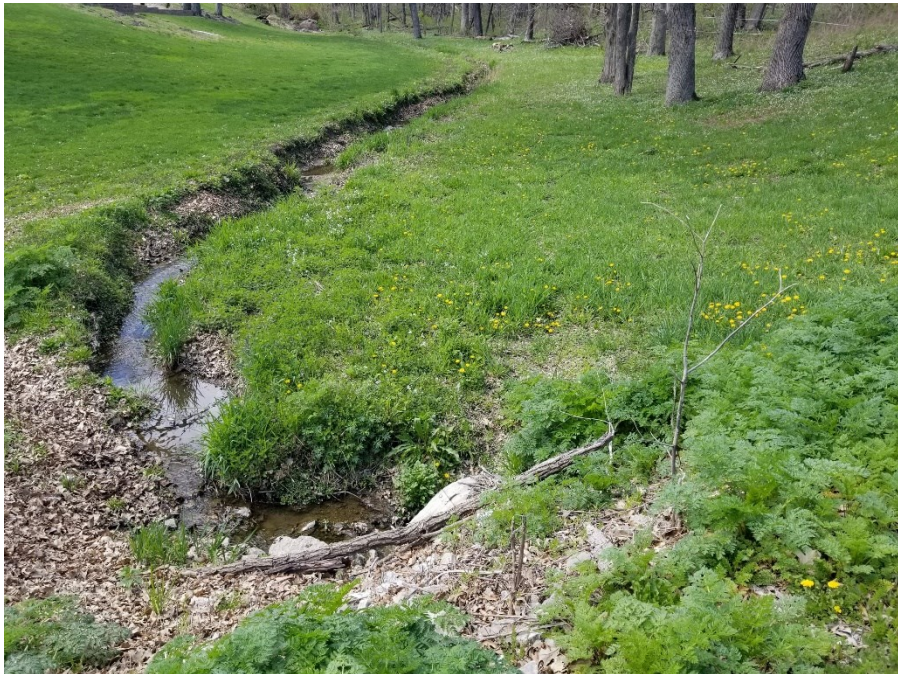
Streambank Erosion: (Top) Site 1; (Bottom) Site 10

- Limit lawn waste to lake
    - Eliminate or reduce lawn fertilizer
    - Native vegetation and buffers along shoreline
  - Address watershed tour sites highlighted for erosion issues within the POA footprint

- Shoreline erosion
    - Streambank, ravine and swale erosion
  - Assess ability to dredge lake. Cost estimates, spoils areas.
  - Develop partnerships for watershed management:

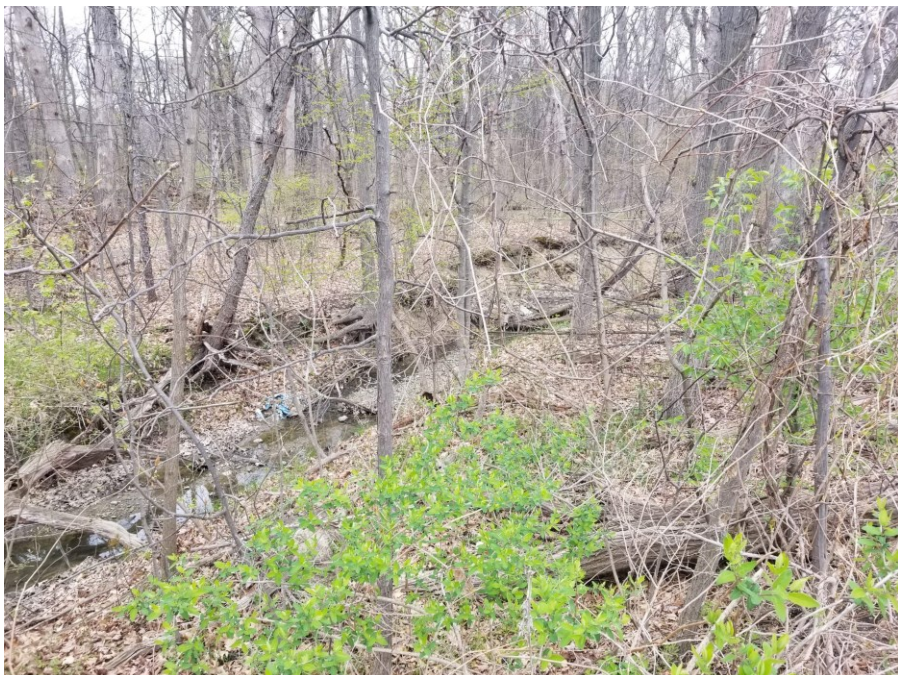
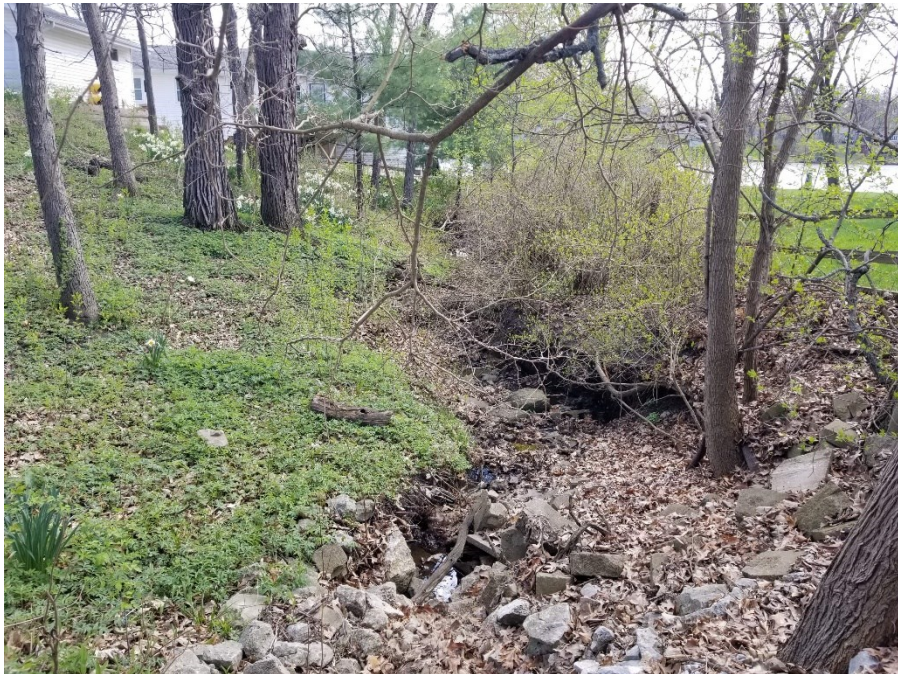
Streambank Erosion: (Top Site 3); (Bottom) Site 14

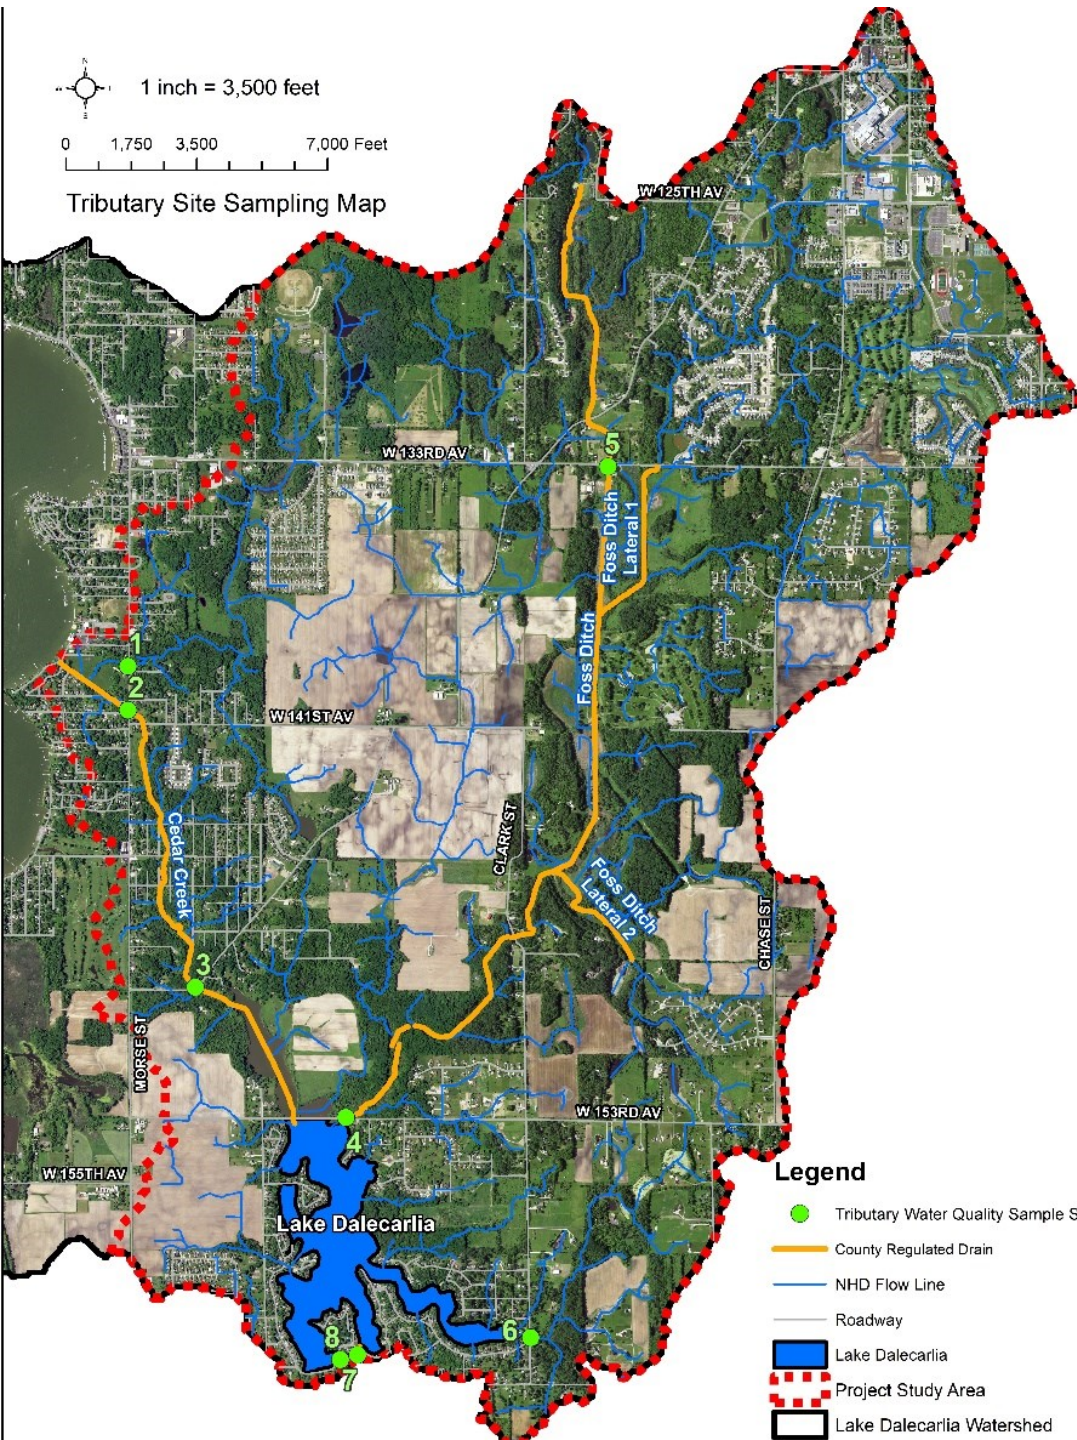
Tributary Site Sampling Map

## Tributary/Watershed Sampling

1. Unnamed Trib to Cedar Creek Morse Rd
2. Cedar Creek at Morse Rd
3. Cedar Creek at Reeder Rd
4. Foss Ditch at 153<sup>rd</sup> Ave
5. Foss Ditch at W 133<sup>rd</sup> Ave
6. Unnamed Tributary Clark St
7. East Lake outlet
8. West Lake outlet

**Sampled during 6 events:** April, May, June, August (2 events), September

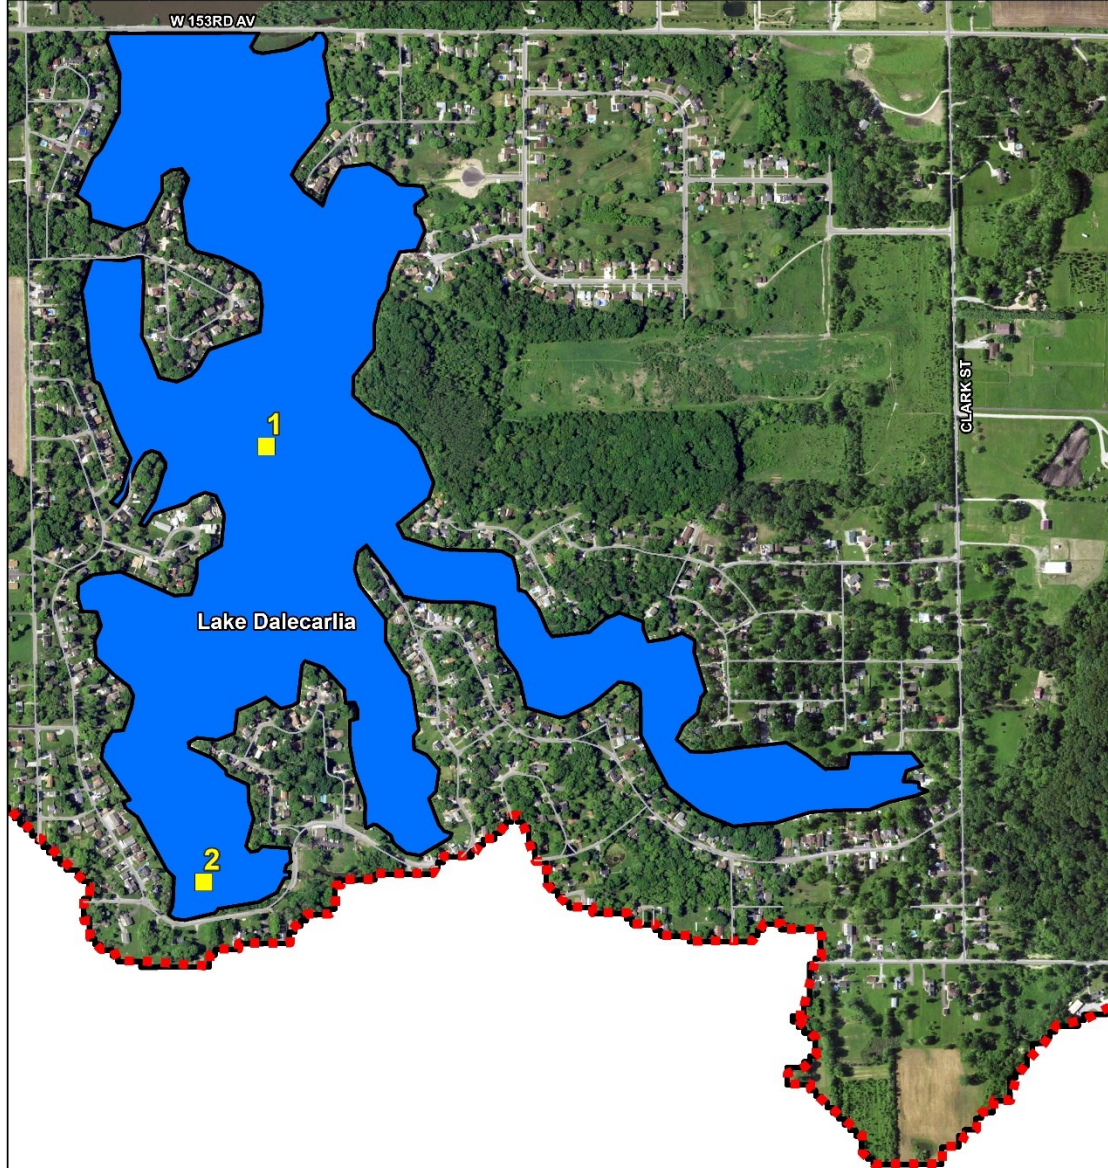
## Samples collected on August 17, 2021

- 2 locations
  - Center of lake (Site 1)
  - Near west outlet (Site 2)
- **Data Collected**
  - Water sample collected at top and bottom of water column
    - Epilimnion (surface)
    - Hypolimnion (bottom)
  - Temperature/Dissolved oxygen profile
  - Light extinction profile
  - Secchi Disk (water clarity)
