# Lake Dalecarlia Watershed Diagnostic Study Public Meeting

PRESENTER:  
Tom Estrem with Cardno

July 18, 2022

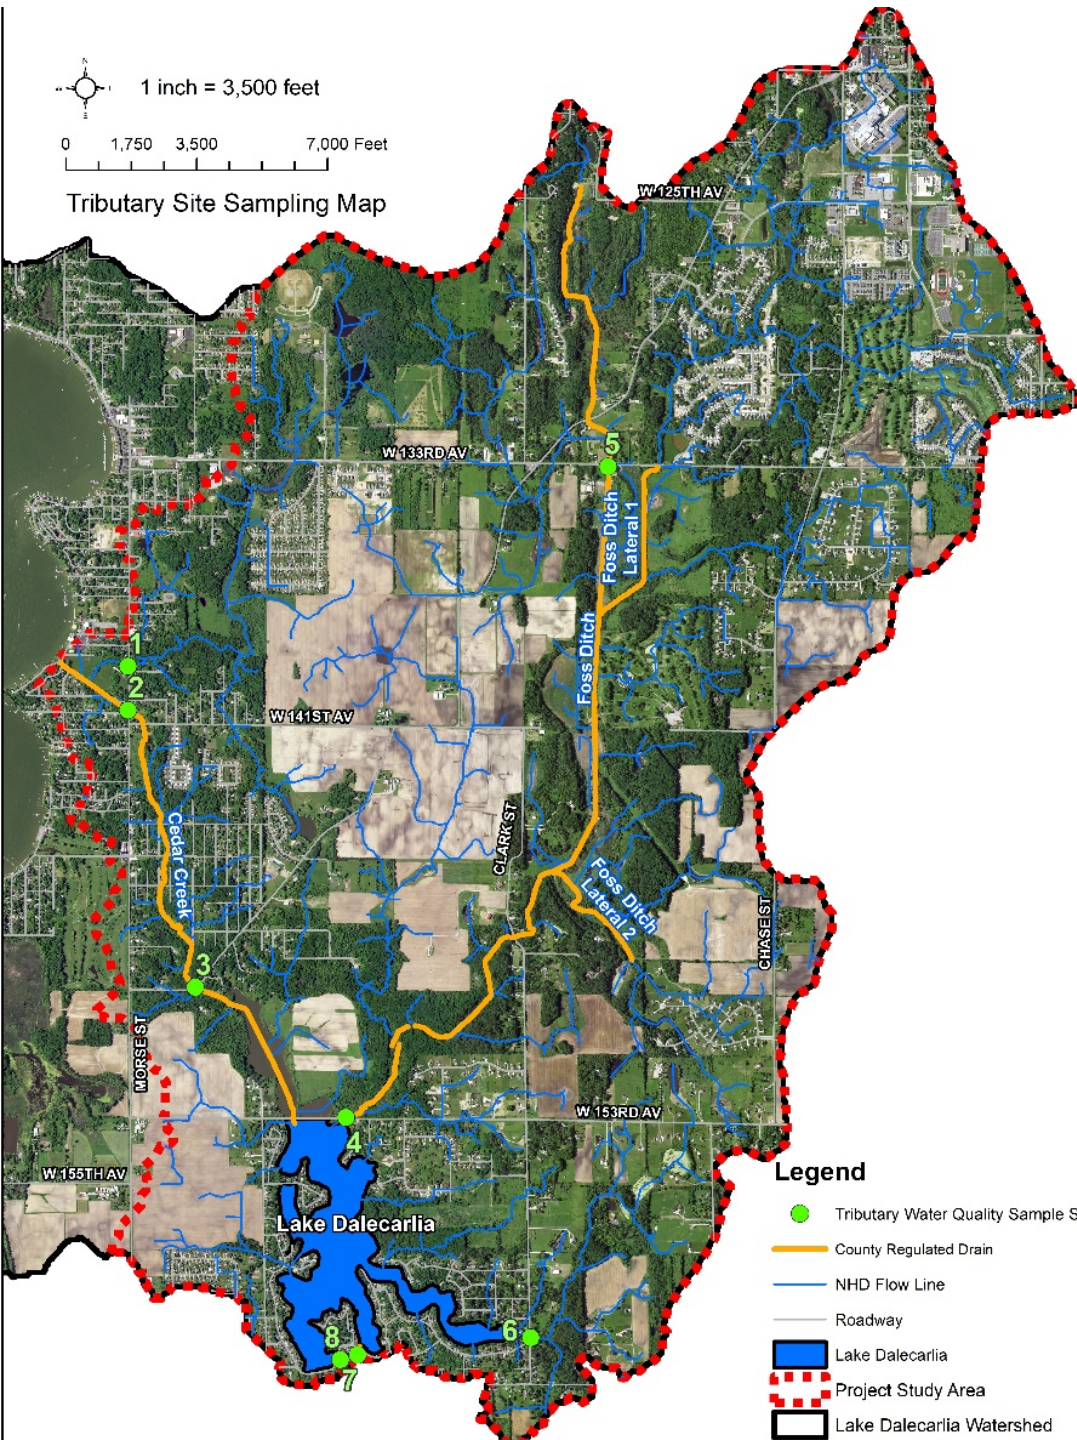
Tributary Site Sampling Map

1. Unnamed Trib to Cedar Creek Morse Rd
2. Cedar Creek at Morse Rd
3. Cedar Creek at Reeder Rd
4. Foss Ditch at 153<sup>rd</sup> Ave
5. Foss Ditch at W 133<sup>rd</sup> Ave
6. Unnamed Tributary Clark St
7. East Lake outlet
8. West Lake outlet

**Sampled during 6 events:** April, May, June, August (2 events), September

Physical and Chemical metrics assessed.

- **Ammonia (NH3-N)** - Exceeded Indiana Administrative Code (IAC) at all sites
- ***E. coli*** concentrations variable at all sites.
  - Lake outlets low below State Standard,
  - Foss Ditch Site 4 lowest from other sites
  - State Standard is 235 MPN/100 mL
- **Nitrate (NO3)** concentrations low- all below 1.0 which is good
- **Total phosphorus (TP-P)**- overall high- Would like to see below 0.1 mg/L
- **Soluble Reactive Phosphorus (SRP)** – similar to Total phosphorus high
- **Total Suspended Solids (TSS)** – less than 25 mg/L is acceptable- only Site 4 Foss Ditch achieved.
- Site 4: Foss Ditch had the most stable parameters throughout sampling period
  - chemical concentrations lower at downstream end
  - TSS lowest at Site 4-suggest sediment trap is working

- Site 2 = Cedar Creek watershed loading ; Site 4 = Foss Ditch watershed loading; Site 6 = SE Unnamed Tributary watershed loading
- Cedar Creek highest loading for TSS and ammonia nitrogen
- Foss Ditch highest loading for phosphorus and nitrate nitrogen
- Lake Dalecarlia is functioning as a “sediment sink” = less nutrients and sediment leaving than entering

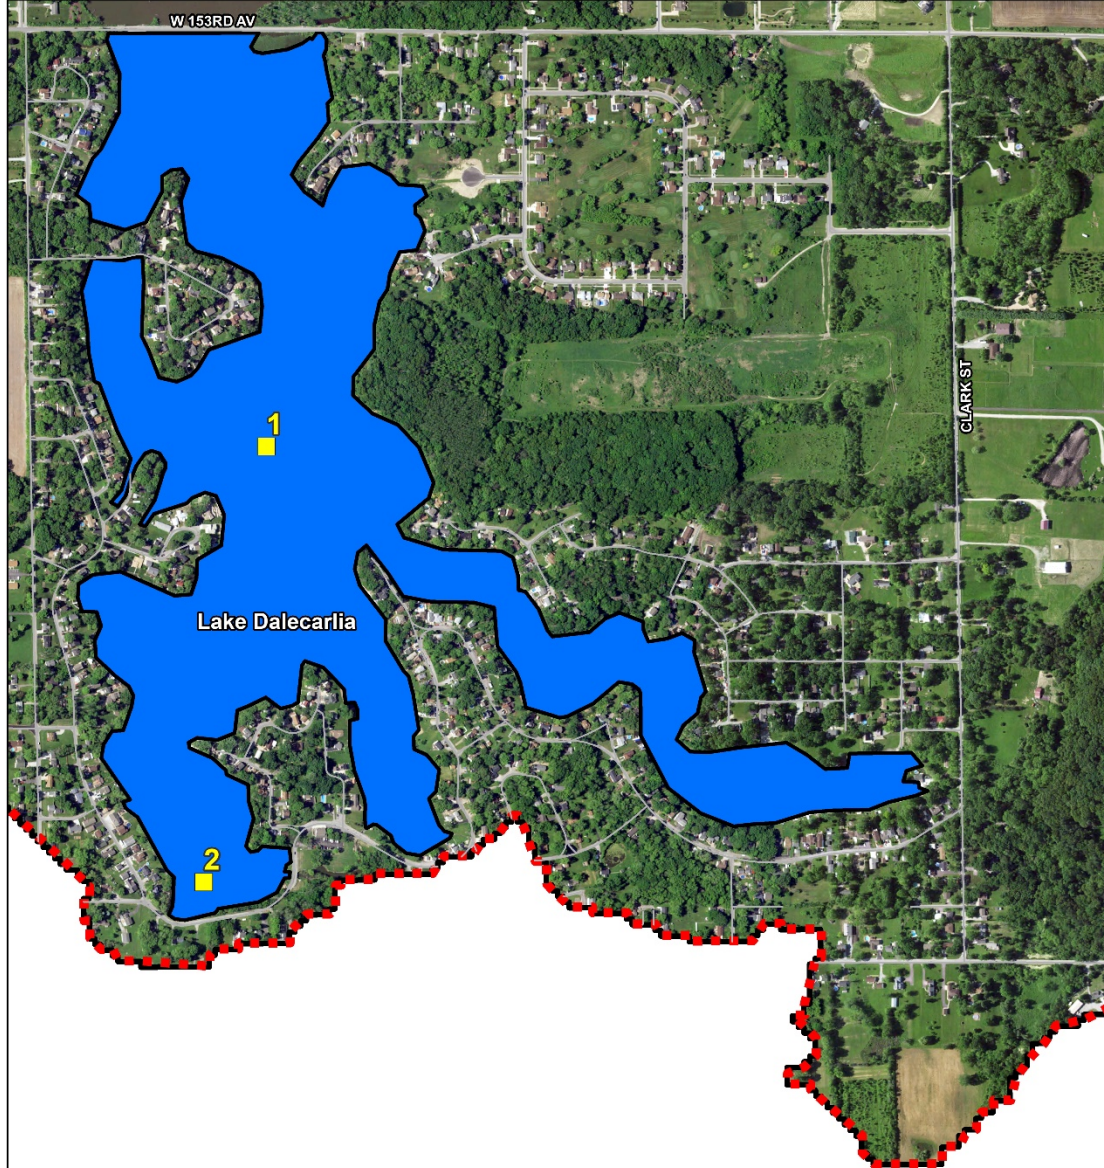
- 2 locations
  - Center of lake (Site 1)
  - Near west outlet (Site 2)
- **Data Collected**
  - Water sample collected at top and bottom of water column
    - Epilimnion (surface)
    - Hypolimnion (bottom)
  - Temperature/Dissolved oxygen profile
  - Light extinction profile
  - Secchi Disk (water clarity)

- No change in characteristics from top to bottom of water column
  - Too shallow to stratify
  - No internal release of phosphorus from sediments suggested-also why SRP is low.
- Secchi Disk reading very low – poor water clarity – less than most Indiana lakes
- pH and conductivity normal
- Ammonia and Nitrate low because water column is oxygenated – lower than most Indiana lakes
- Total phosphorus is high – about average with most Indiana lakes
- Soluble Reactive Phosphorus is low – lower than most Indiana lakes
- Adequate dissolved oxygen within water column - all above 6 mg/L
- Light extinction profile estimates 1% light level is at 2.75 ft
  - Below 2.75 feet suggest no aquatic plants can grow.

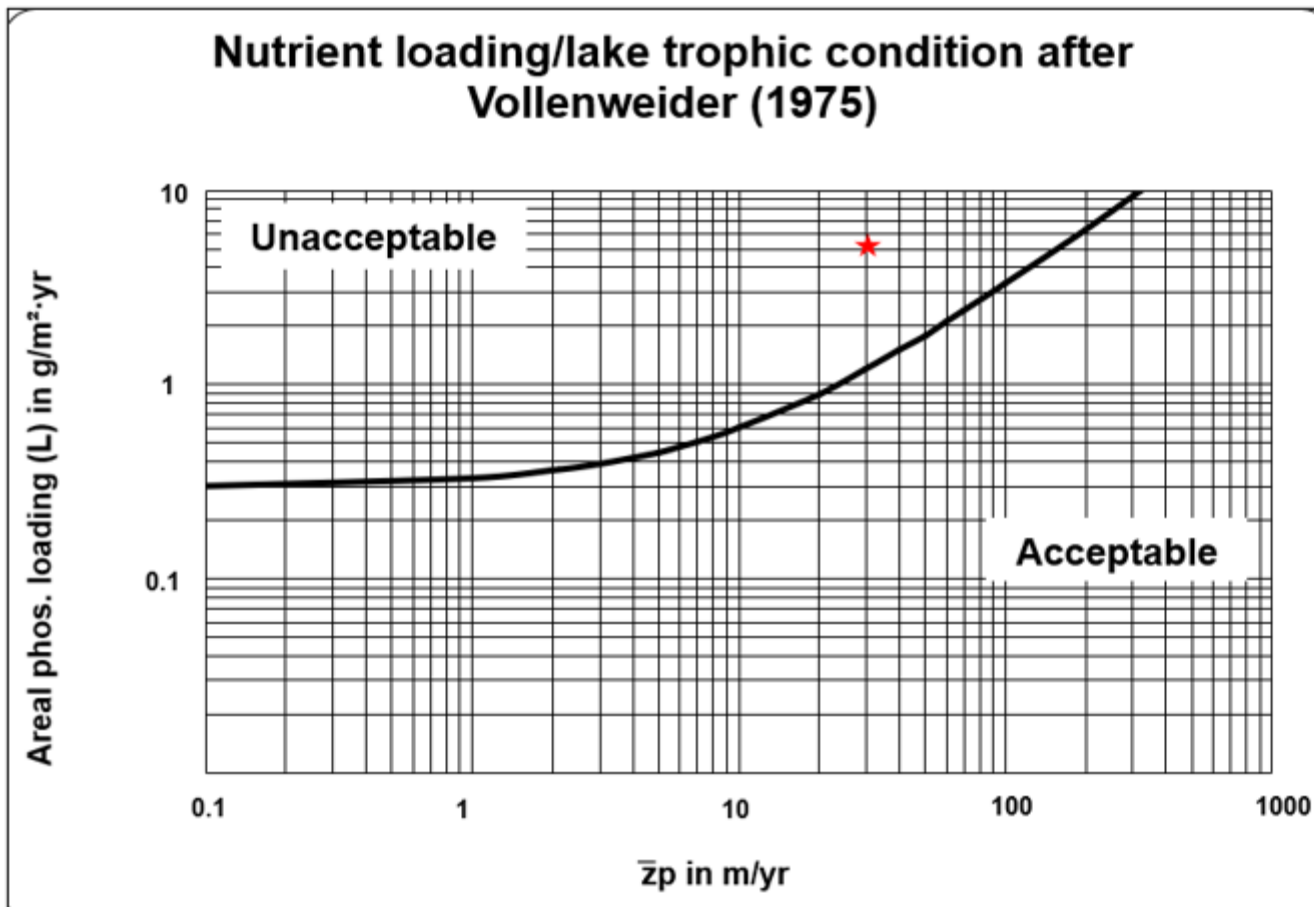
Figure 20. Phosphorus loading to Lake Dalecarlia compared to acceptable loadings determined from Vollenweider's model. The dark line represents the upper limit for acceptable loading. Current Lake Dalecarlia areal loading indicated by red star (5.090 g/m<sup>2</sup>-yr).

- Phosphorus modeling suggests **75% reduction** in phosphorus loading from watershed is needed to maintain acceptable phosphorus concentration in Lake Dalecarlia
